TS-PIC-20305593S
JUNE 2003

AERIAL PHOTOGRAPHIC ANALYSIS OF N-FORCER SITE DEARBORN, MICHIGAN

Dearborn, Michigan

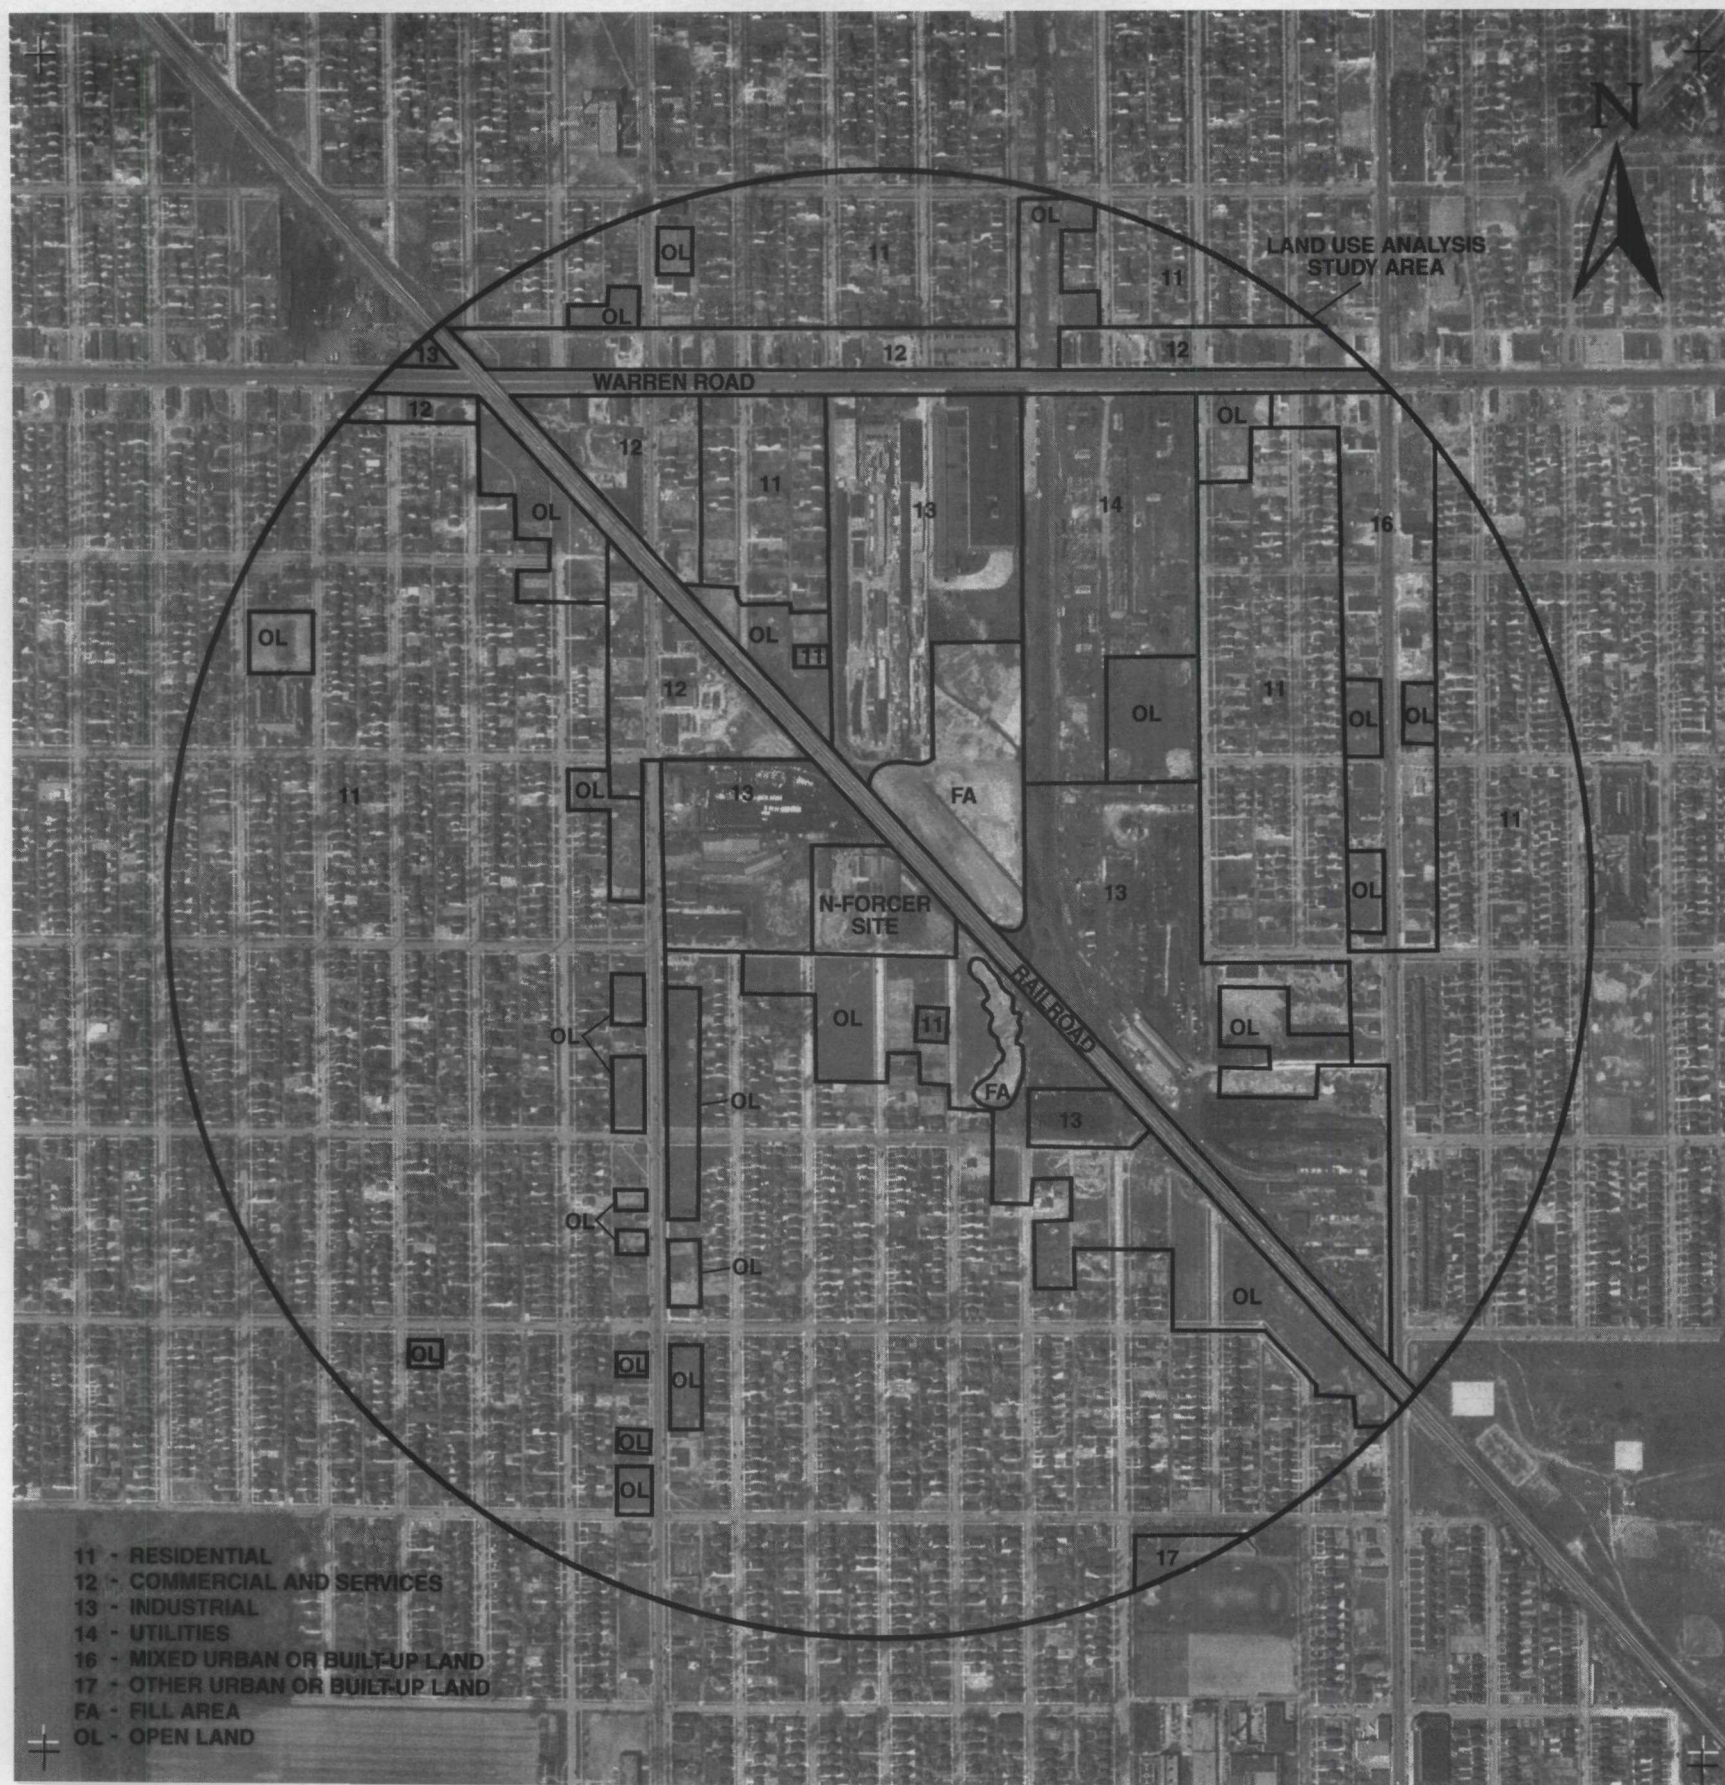
FIGURE 3
N-FORCER SITE

APRIL 20, 1951 LAND USE ANALYSIS (FIGURE 3)

The area within a 0.8-kilometer (0.5-mile) radius of the site is primarily in Residential land use. Other land use classifications noted, listed in approximate descending order of ground surface covered, include the following: Industrial, Open Land, Commercial and Services, Utilities, Mixed Urban or Built-Up Land, and Other Urban or Built-Up Land.

The parcels of Open Land annotated on this figure occur primarily as undeveloped lots in or adjacent to Residential areas. Two fill areas are noted, one to the southeast of the N-Forcer site and one adjacent to the railroad tracks northeast of the site.

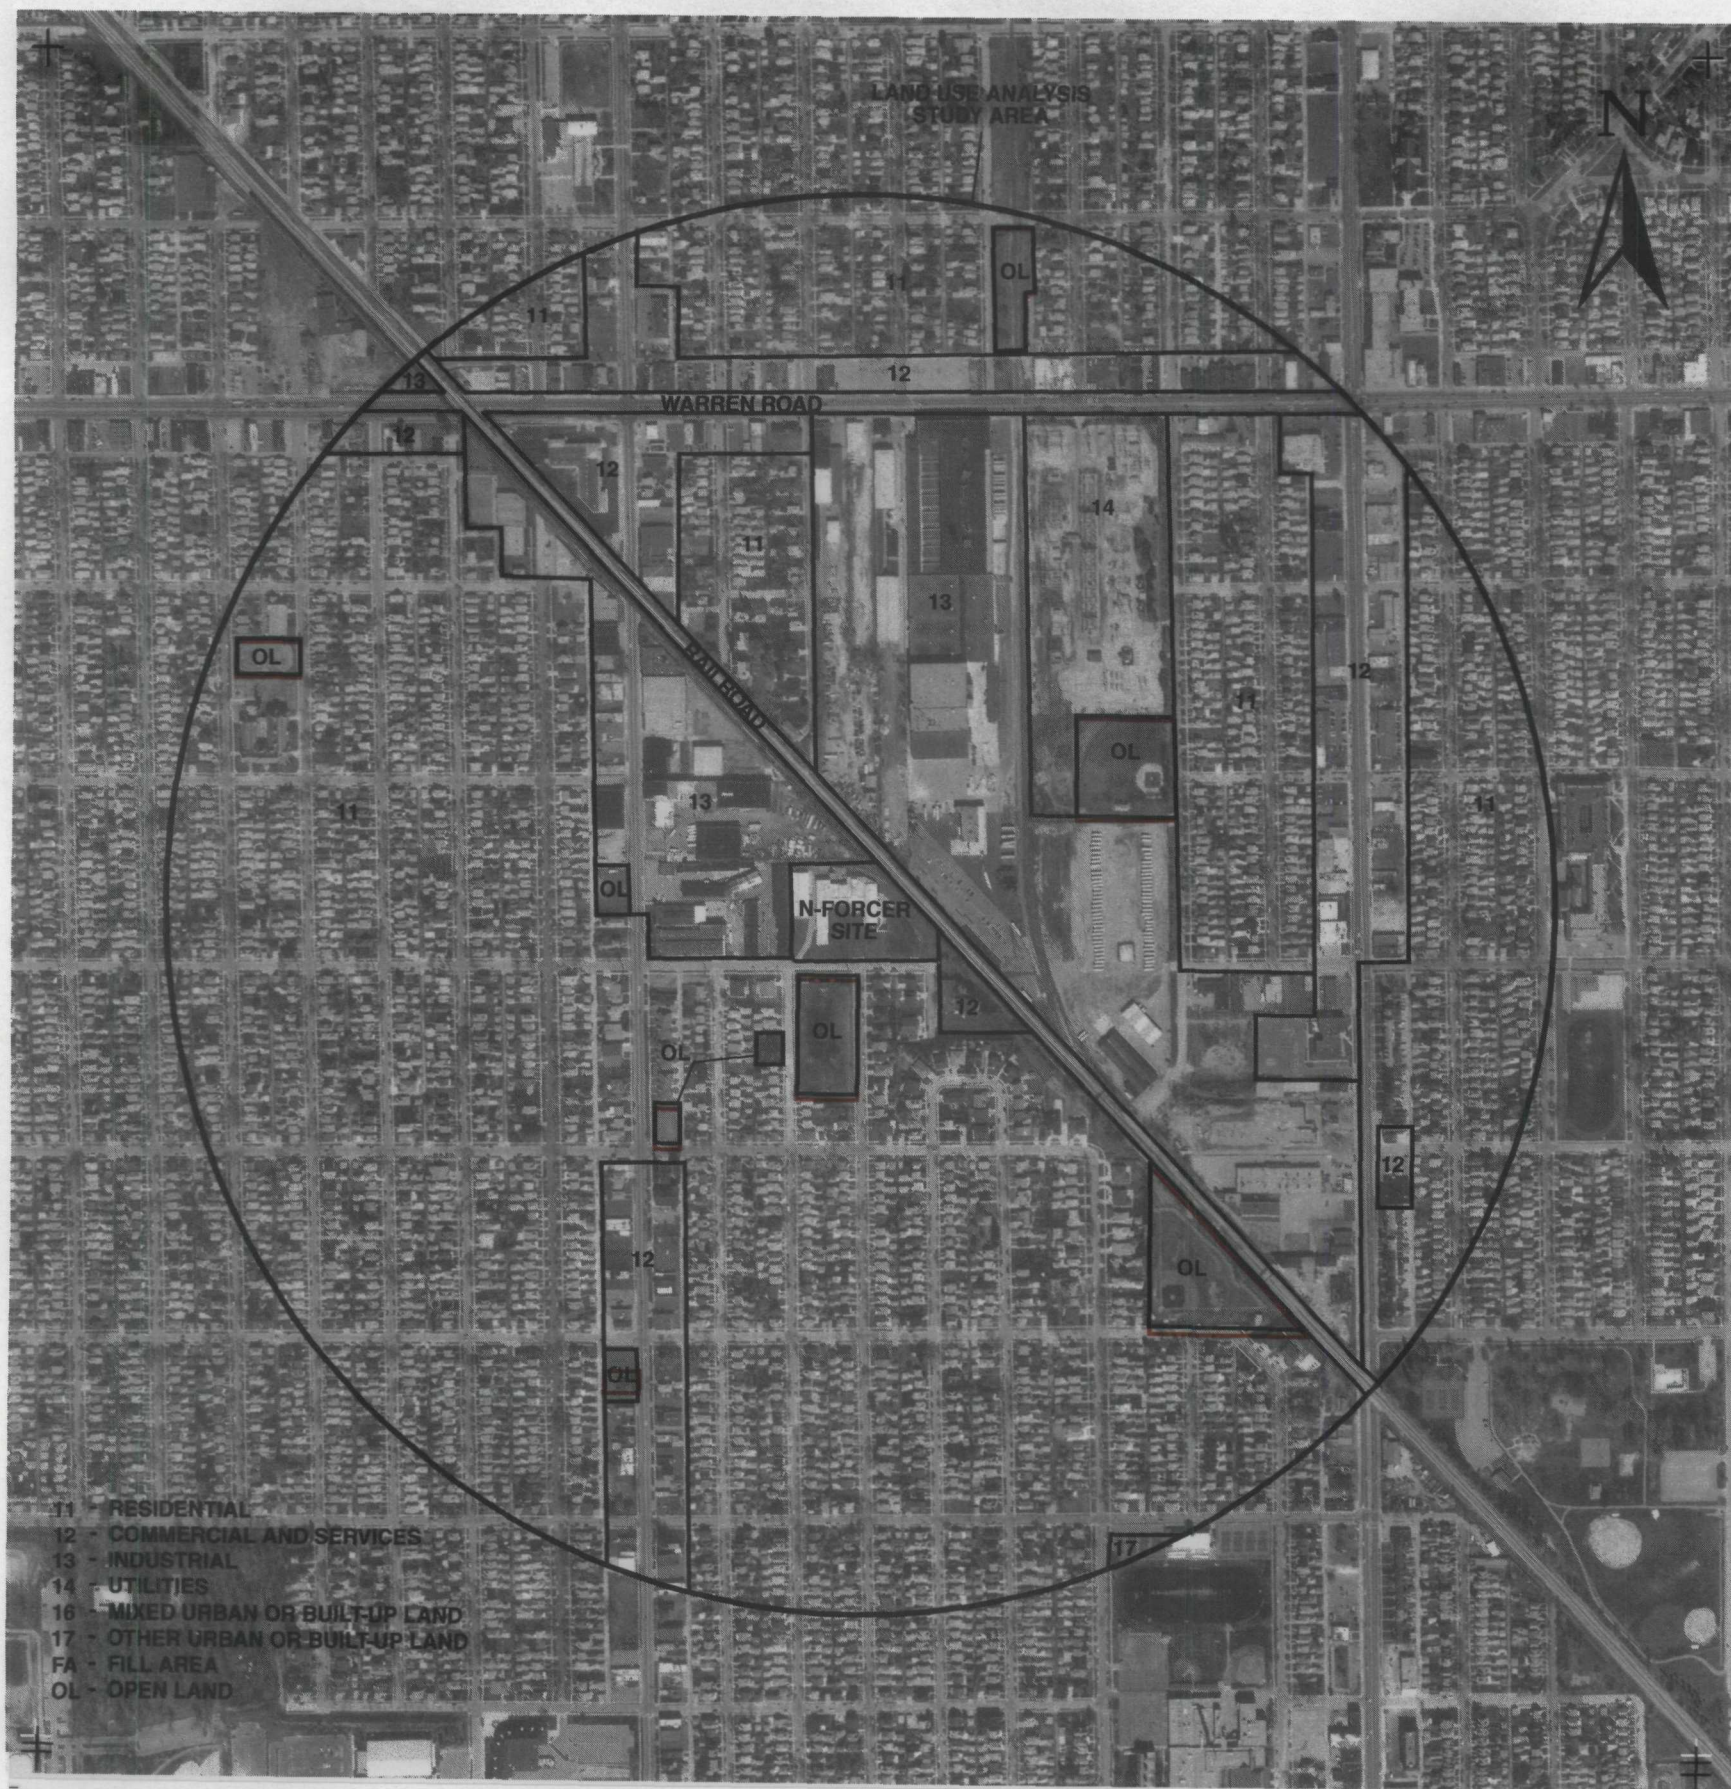
FIGURE 4
FIGURE 4A
N-FORCER SITE

MARCH 26, 2000 LAND USE ANALYSIS (FIGURE 4)

As on the 1951 photograph (FIGURE 3), the area within a 0.8-kilometer (0.5-mile) radius of the site is primarily in Residential land use. Other land use classifications noted, listed in approximate descending order of ground surface covered, include the following: Industrial, Commercial and Services, Utilities, Open Land, and Other Urban or Built-Up Land.

Changes in land use between 1951 and 2000 include an increase in the industrial and Commercial and Services classifications and a decrease in the Open Land classification. The larger of the remaining parcels of Open Land are in use as athletic fields (not annotated). The smaller parcels are undeveloped lots in Residential areas.

The Fill Area noted adjacent to the railroad tracks northeast of the N-Forcer site on the 1951 photograph (FIGURE 3) is now classified as Industrial. The fill area noted to the southeast of the N-Forcer site on the 1951 photograph (FIGURE 3) is now classified as Commercial and Services and Residential.

MARCH 26, 2000 LAND USE ANALYSIS (FIGURE 4A)

This figure identifies parcels of Open Land that have remained open since 1951 (FIGURE 3).

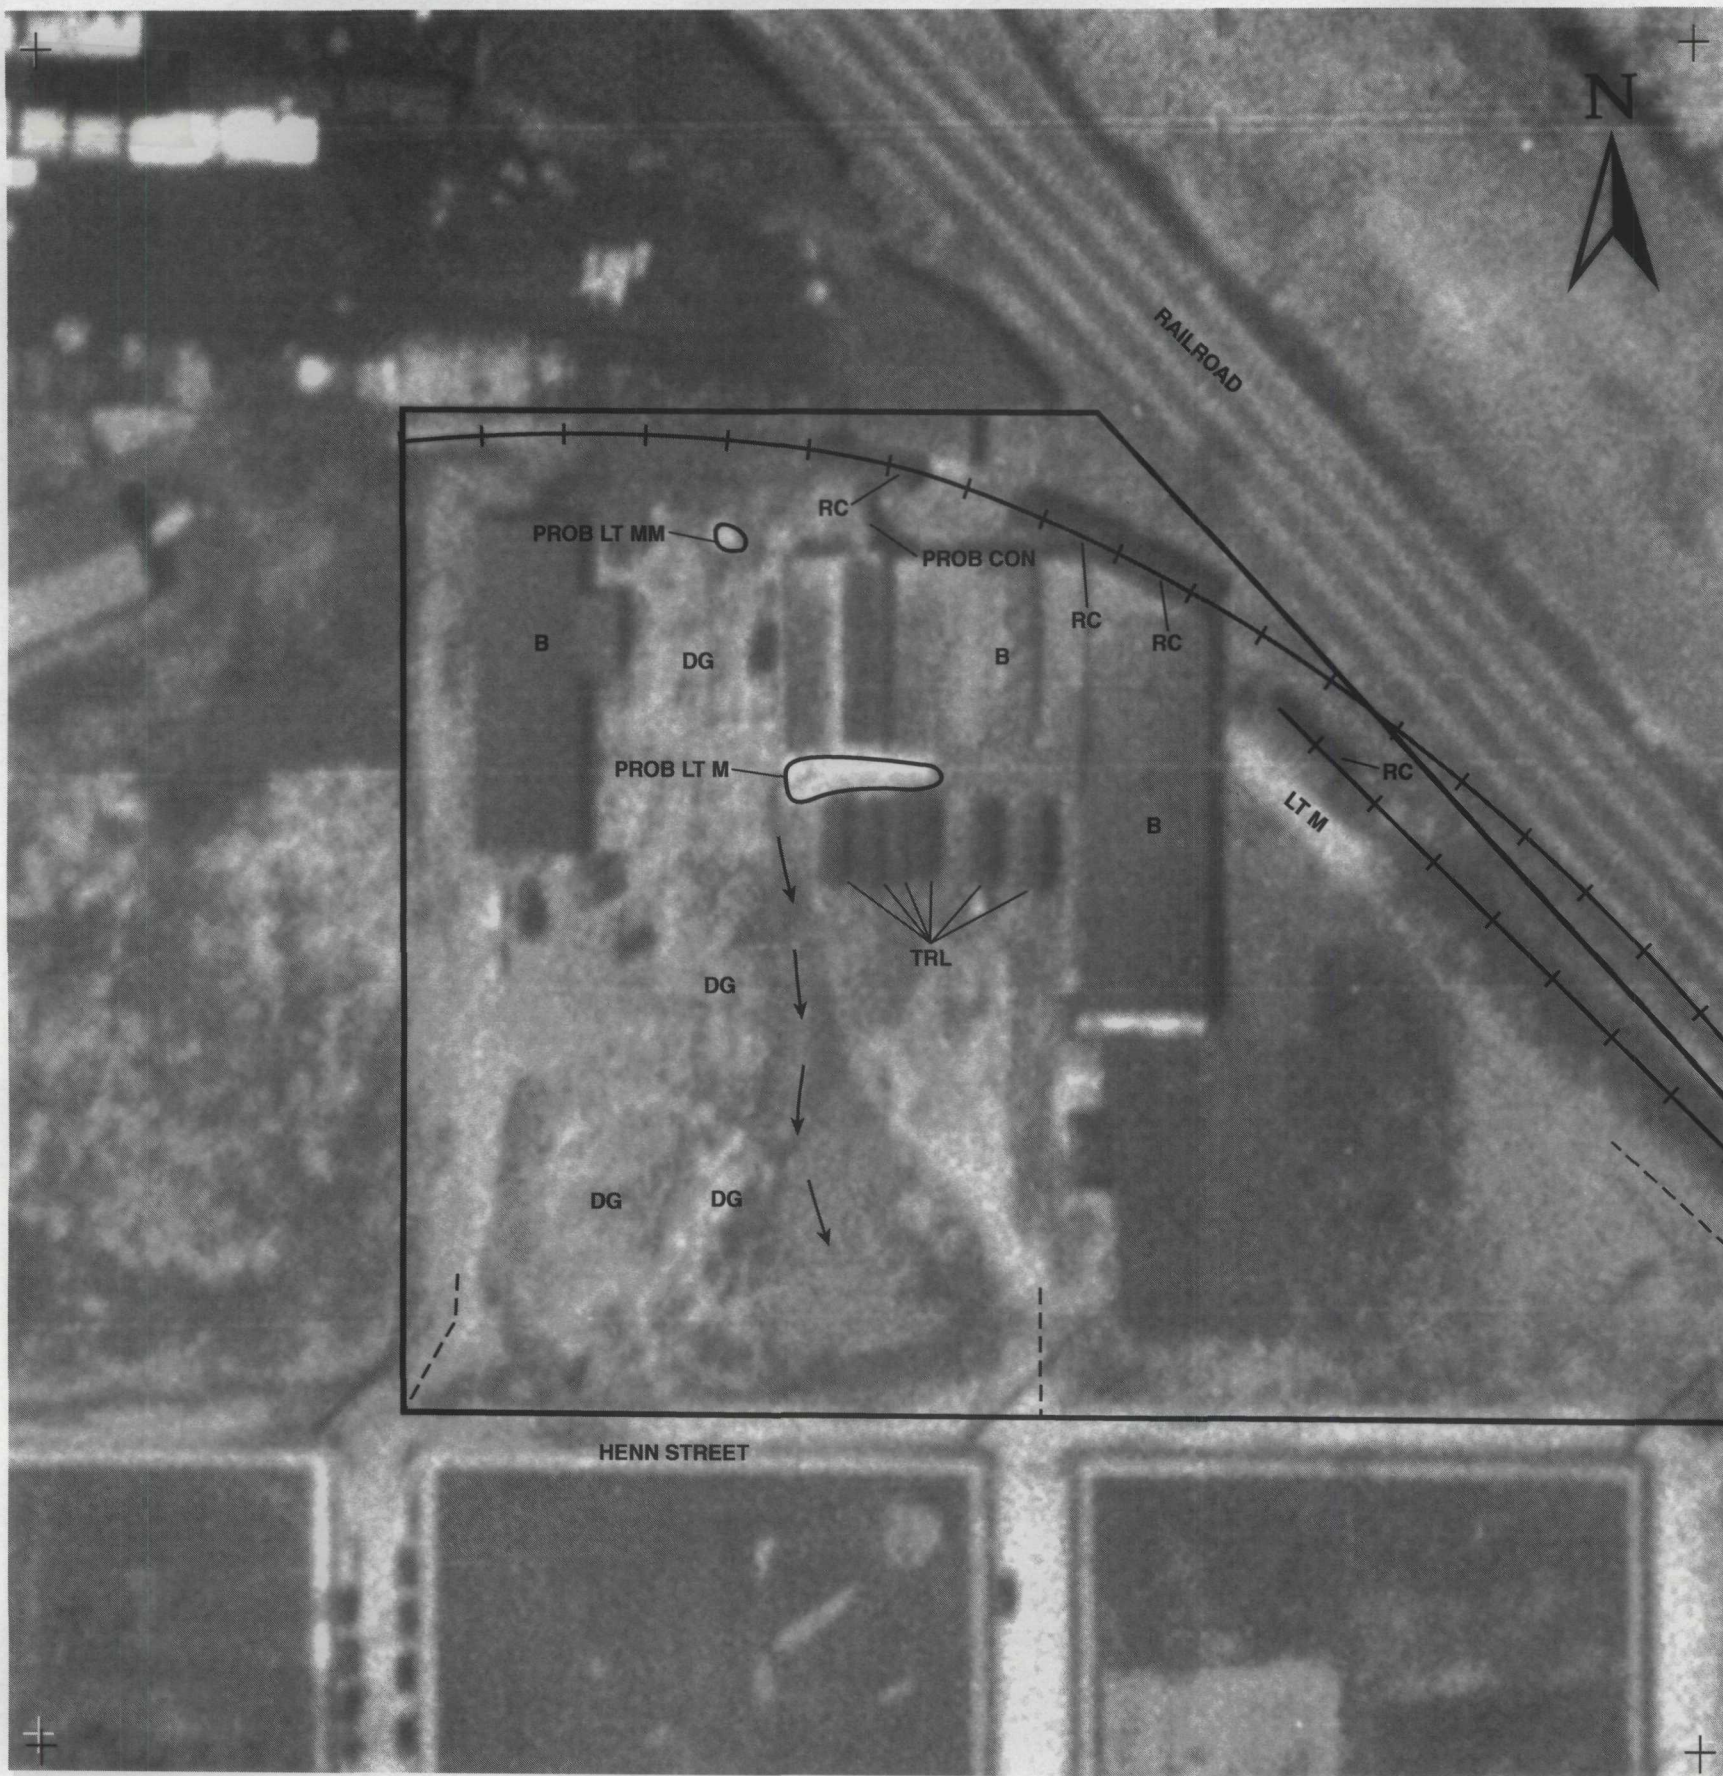
FIGURE 5
N-FORCER SITE

APRIL 20, 1951 (FIGURE 5)

The N-Forcer site is bounded by industrial facilities (not annotated) to the north and west, by railroad tracks to the east, and by Henn Street to the south, which provides vehicular access to the site. Open lots (not annotated) are present in a residential area to the south of Henn Street.

The site contains two adjoining buildings (B) in the north-central portion of the site that appear to be the production facility and will be identified as such for the remainder of this report. A third building is located in the northwestern portion of the site. Two rail spurs leading from the railroad to the east service the production facility.

Probable light-toned particulate material (not annotated) is noted on portions of the roof of the production facility. Probable (PROB) light-toned (LT) material (M) is seen adjacent to the southwestern portion of the production facility and to the east of the production facility, adjacent to the rail spur. This latter light-toned material may have resulted from loading and/or unloading activities between railcars and the production facility. Probable light-toned mounded material (MM) is noted to the northwest of the production facility. A probable conveyor (CON) leads from the northern side of the production facility towards the rail spur to the north. Six trailers (TRL) are visible on an unpaved parking lot (not annotated) south of the production facility.

To the west of the production facility, an area of disturbed ground (DG) that extends to the southern portion of the site is noted. A drainage pathway extends from the northwestern corner of the production facility into the southern portion of the site.

Four railcars (RC) are present on the rail spurs.

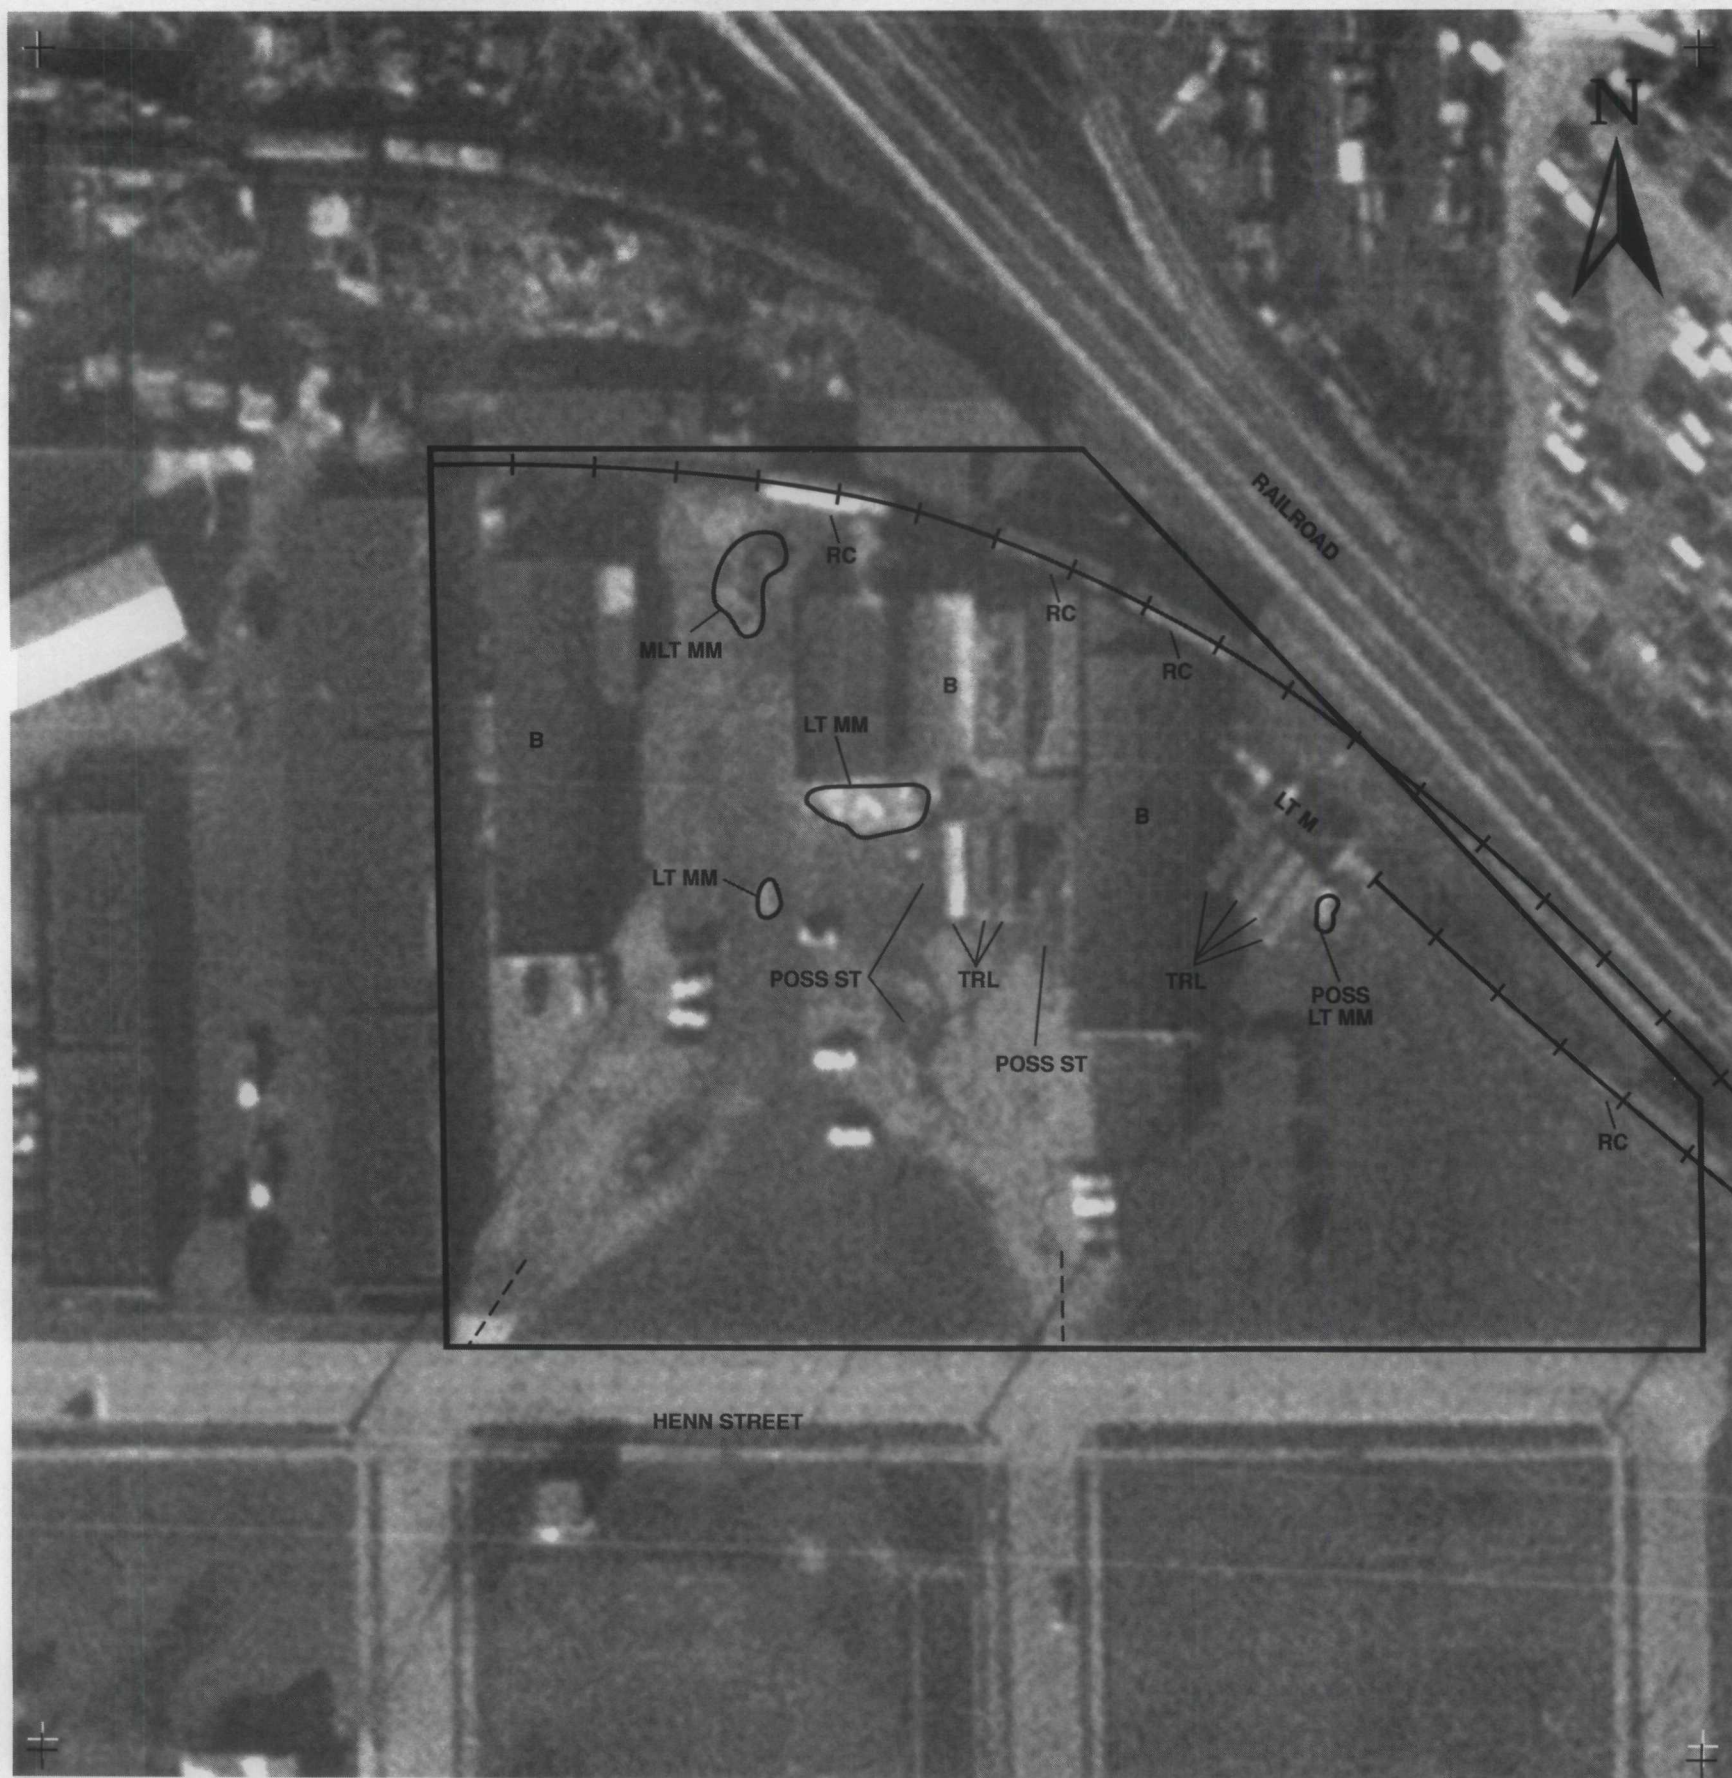
FIGURE 7
N-FORCER SITE

NOVEMBER 21, 1966 (FIGURE 7)

Light-toned mounded material is seen adjacent to the southwestern side of the production facility, where light-toned material was previously noted on the 1951 photograph (FIGURE 5). Further to the southwest, a smaller area of light-toned mounded material present on the 1956 photograph (FIGURE 6) is once again noted. Light-toned material is noted adjacent to the rail spur to the east of the production facility where it has been seen on all photographs since 1951 (FIGURE 5), and possible light-toned material is noted further to the south. Multi-toned (MLT) mounded material is visible to the northwest of the production facility.

Three trailers and three areas of possible staining are seen on the parking lot (not annotated) south of the production facility. Four trailers are present east of the production facility.

Four railcars are visible on the rail spurs.

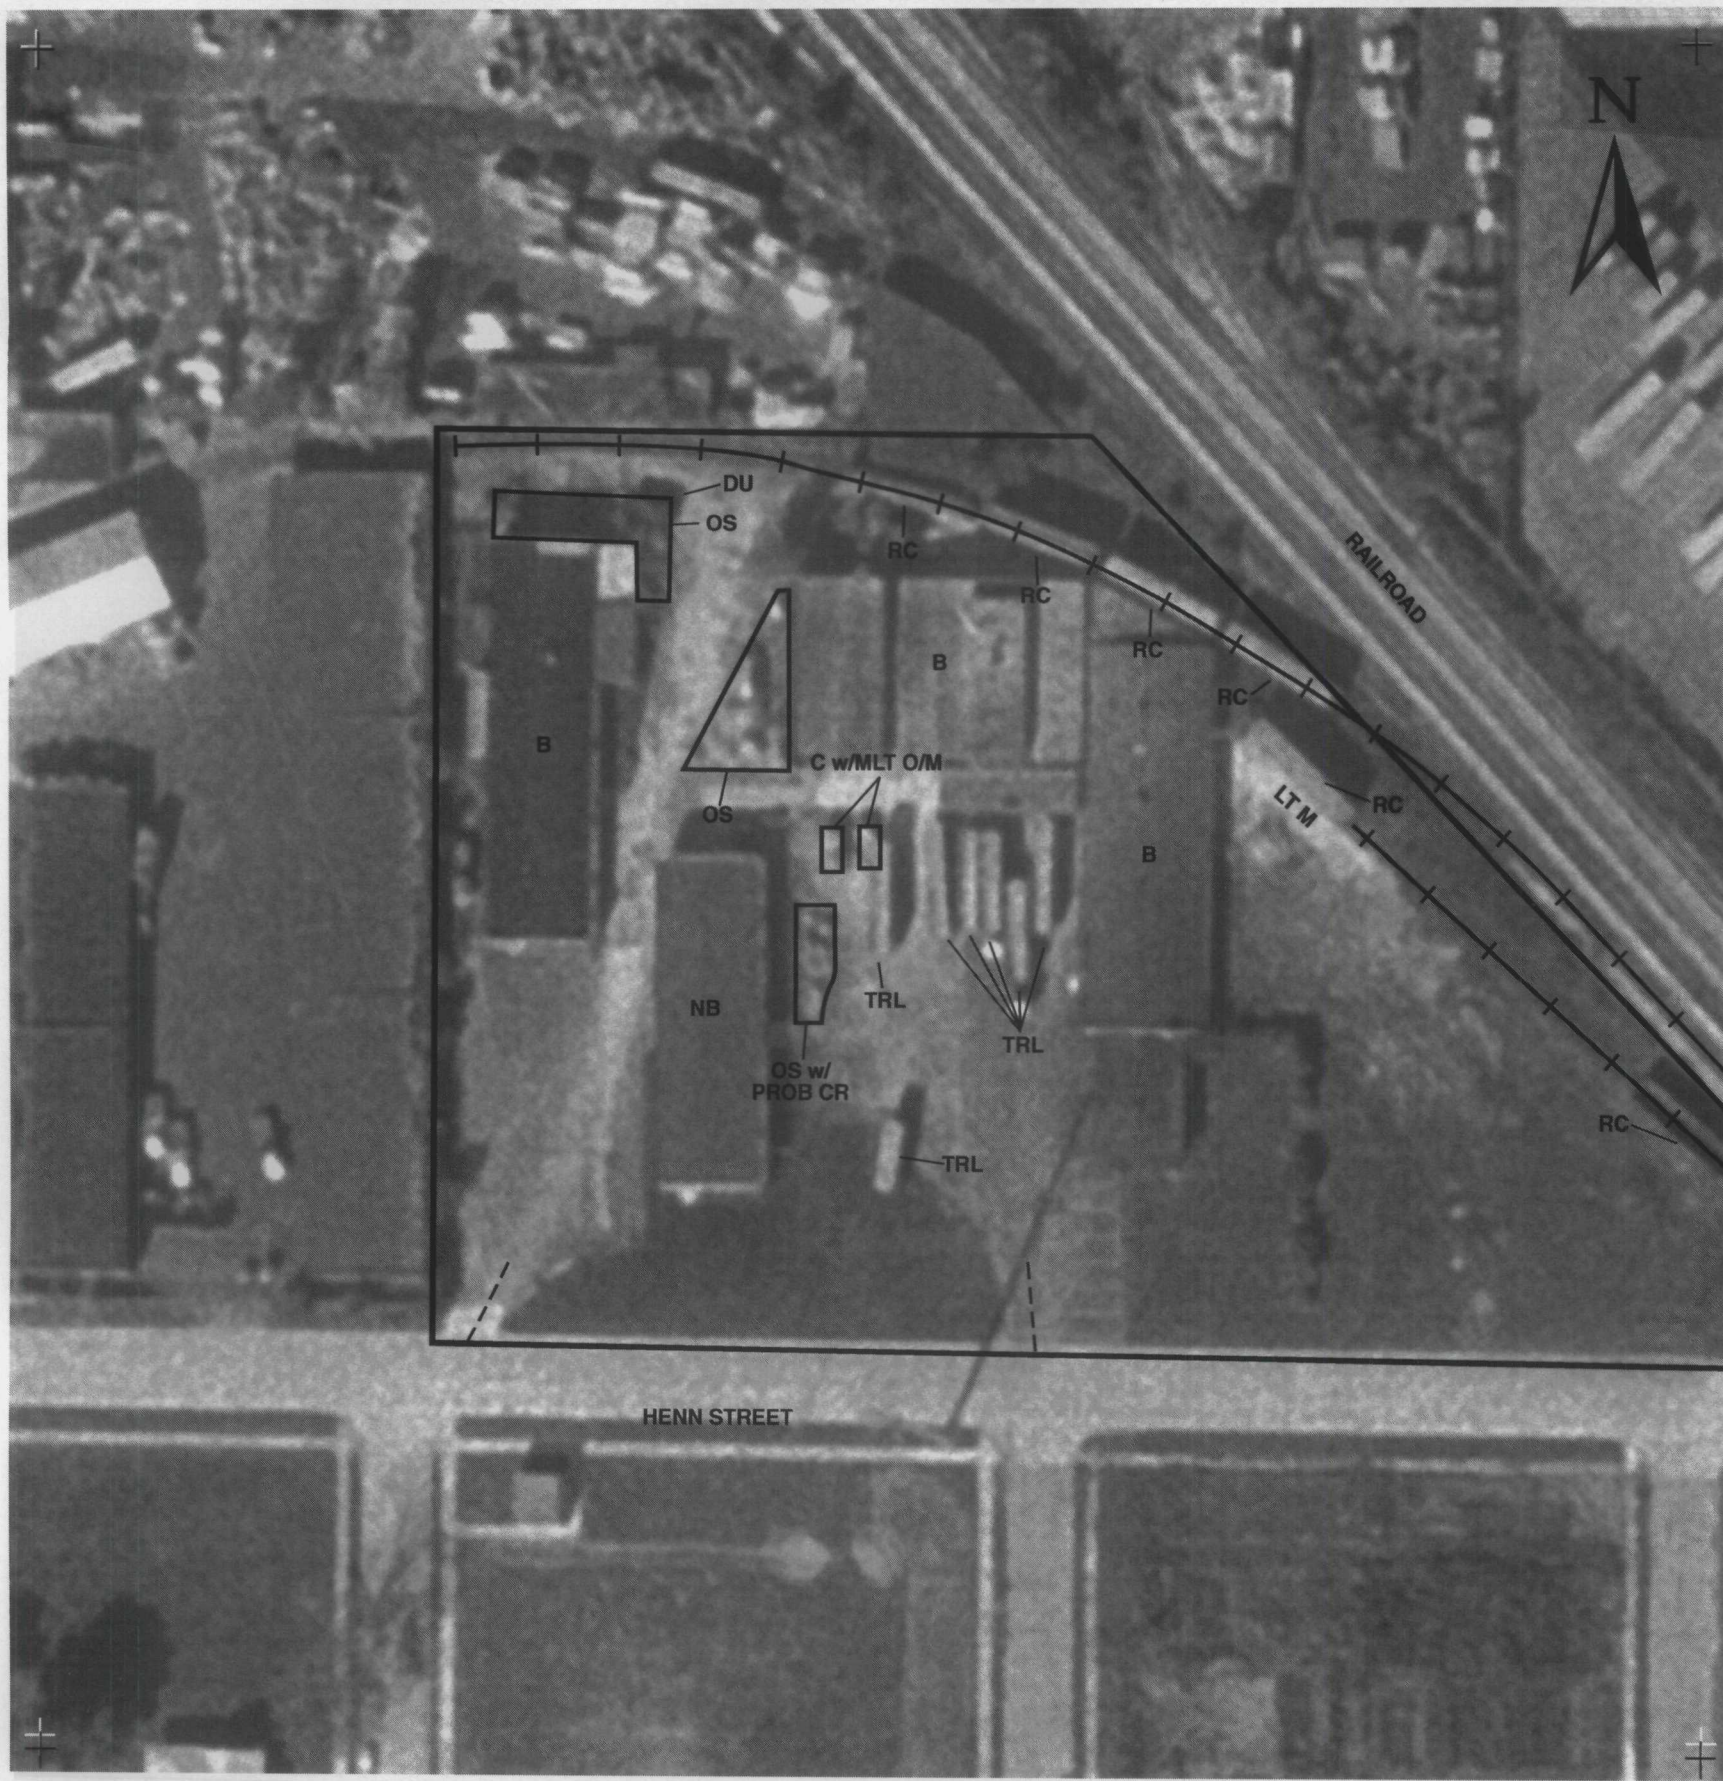
FIGURE 8
N-FORCER SITE

OCTOBER 15, 1973 (FIGURE 8)

A new building (NB), first noted on the 1972 photographs (not reproduced for this report), is present in the west-central portion of the site. An open storage area (OS) containing probable crates (CR) is seen to the east of this new building. Open storage areas containing unidentified objects (not annotated) are noted adjacent to the western side of the production facility and adjacent to the northern side of the building in the western portion of the site. A dumpster (DU) is visible adjacent to this latter open storage area.

Probable light-toned particulate material (not annotated) is noted on portions of the roof of the production facility. Light-toned material is visible adjacent to the rail spur to the east of the production facility where it has been seen on all photographs since 1951 (FIGURE 5). Two rectangular containers (C) holding multi-toned objects (O) or material are visible in the central portion of the site.

To the south of the production facility, a group of five trailers and two individual trailers are observed.

Six railcars are visible on the rail spurs.

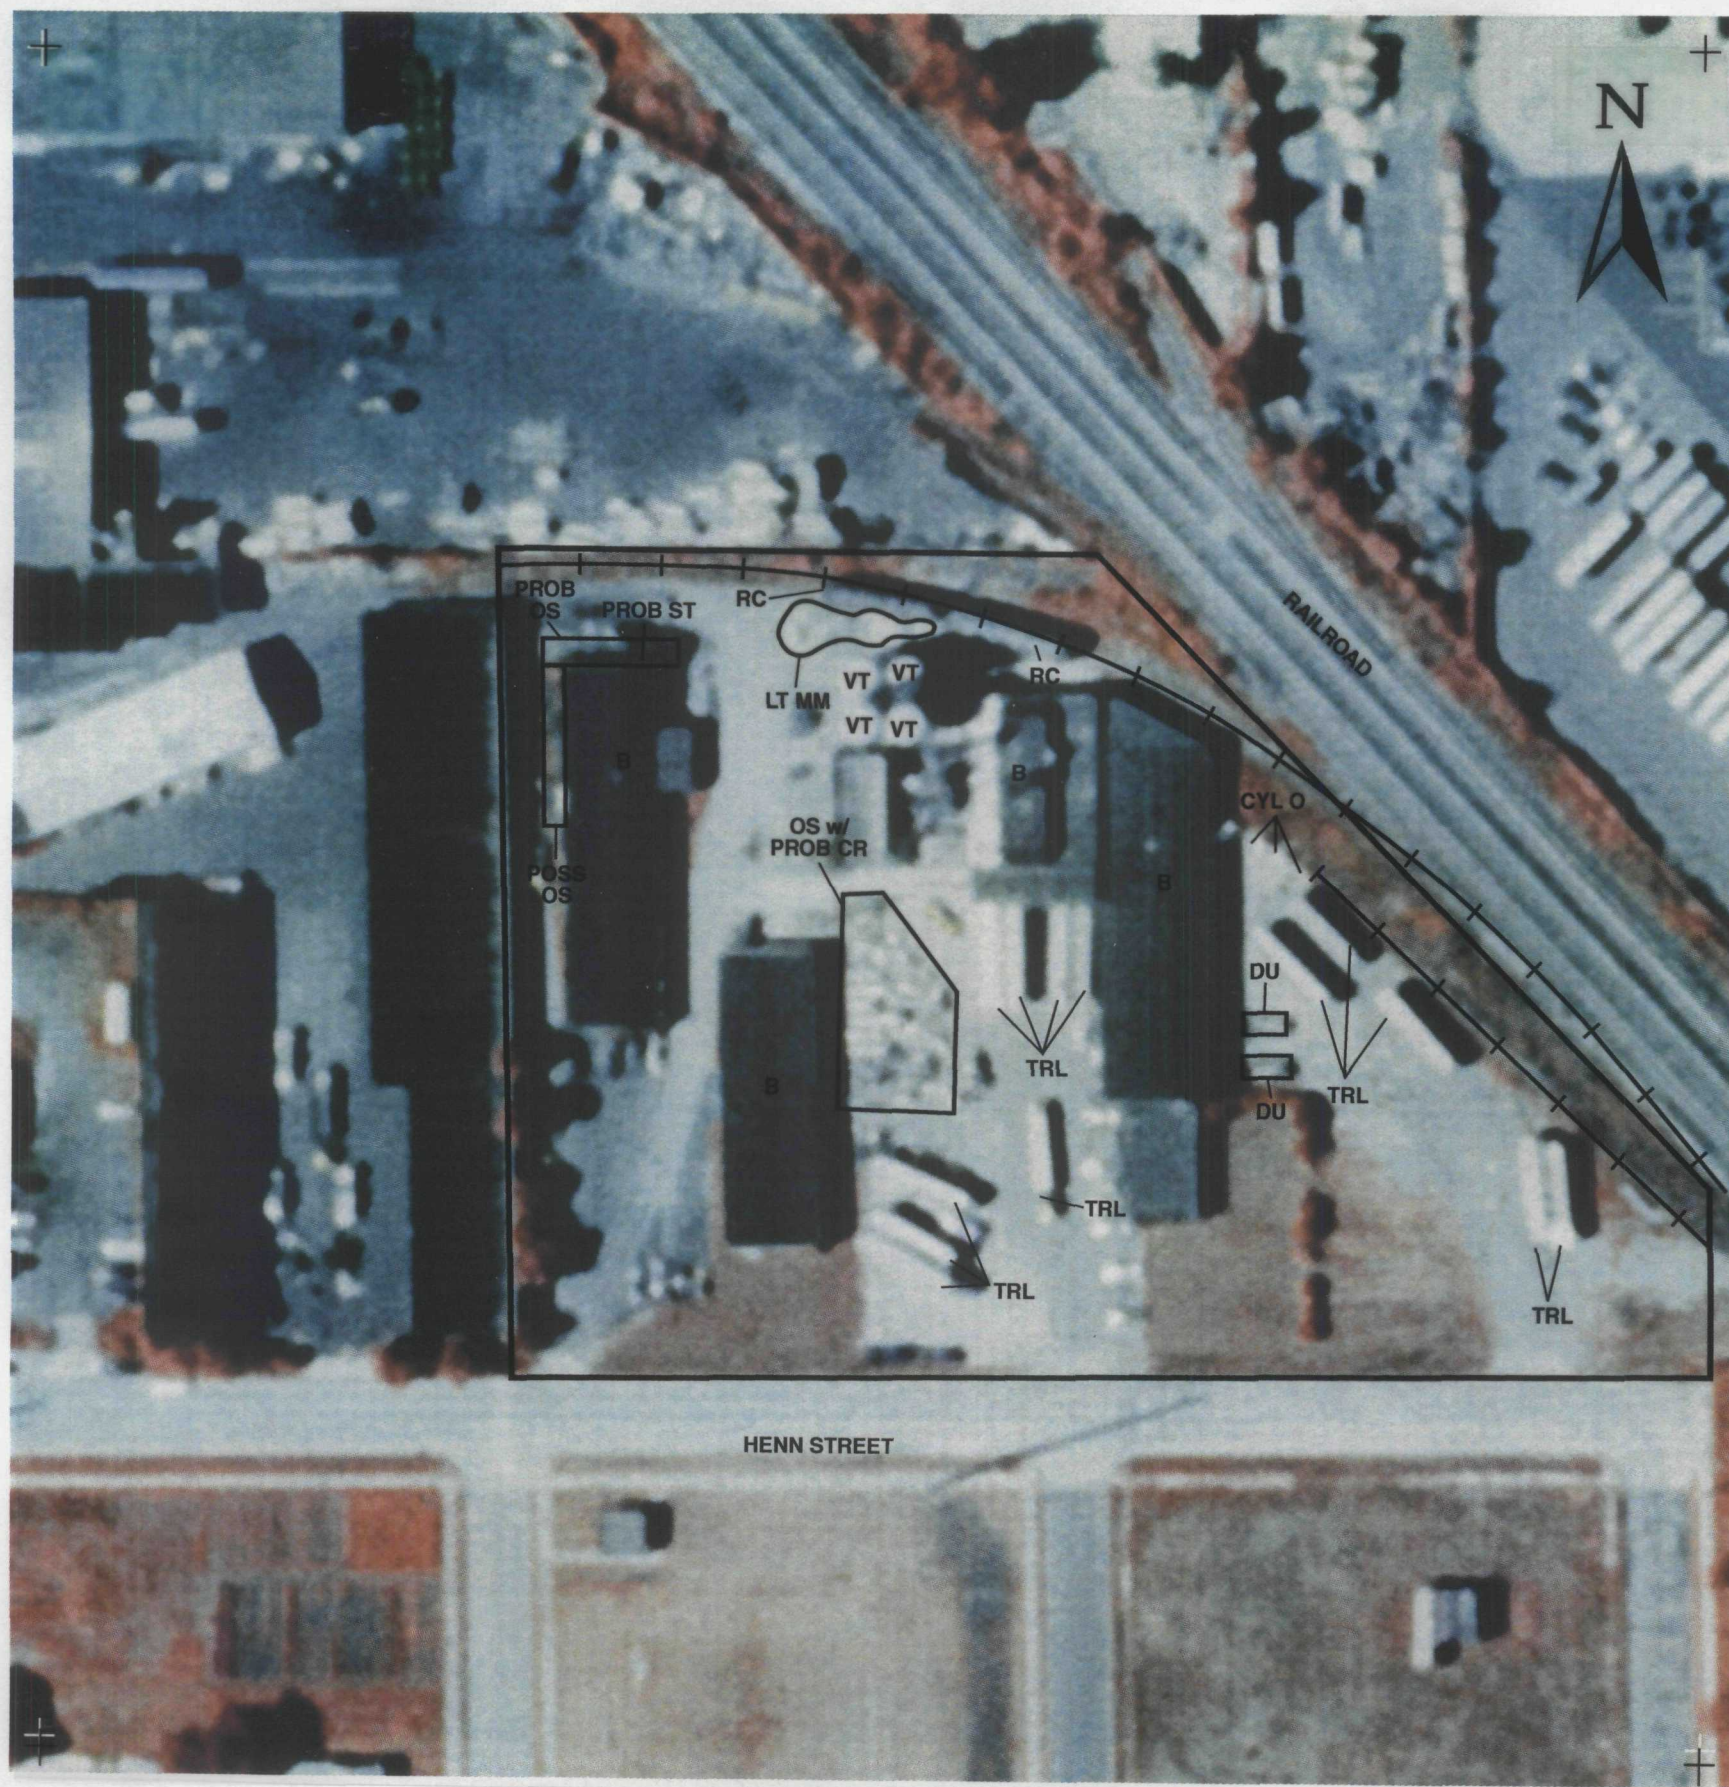
FIGURE 9
N-FORCER SITE

JULY 17, 1978 (FIGURE 9)

Light-toned mounded material and four vertical tanks (VT) are visible northwest of the production facility. These vertical tanks are present on all subsequent photographs in this report and will continue to be annotated, though not further discussed unless associated with an environmentally significant feature. A portion of the roof of the production facility building south of the vertical tanks has been removed (not annotated).

To the east of the production facility, two dumpsters, three cylindrical (CYL) objects, and five trailers are seen. The light-toned material that was visible adjacent to the rail spur east of the production facility from 1951 through 1973 (FIGURES 5 through 8) is no longer present. On the parking lot (not annotated) south of the production facility, eight trailers and an open storage area containing probable crates are noted.

In the northwestern portion of the site, probable staining is visible in a probable open storage area adjacent to the northern edge of the building. A possible open storage area is seen adjacent to the western side of this building.

The rail spur in the southeastern portion of the site appears to have fallen into disuse. Two railcars are present on the northern rail spur.
